## ELTHAM – HERITAGE AT RISK 2010

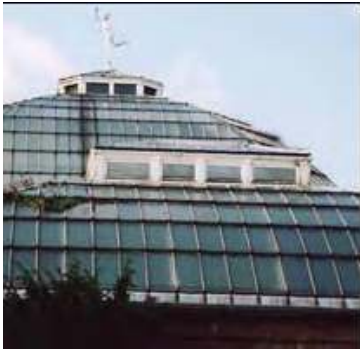
<p><b>SITE NAME:</b> Winter Garden of former Avery Hill Training College, Bexley Road, Eltham SE9</p> <p><b>DESIGNATION:</b> Listed Building Grade II</p> <p><b>CONDITION:</b> Poor</p> <p><b>OCCUPANCY:</b> Not applicable</p> <p><b>PRIORITY:</b> F (A)</p>	<p>Large conservatory with domed glass roofs, surmounted by a figure of Mercury. Built in 1889 in a classical style previously suffering from long term neglect and major deterioration of the fabric. Access to some parts was restricted on health and safety grounds. Listed building consent approved in 2009 for comprehensive internal repairs and renovations. Works have commenced on site.</p>
<p><b>OWNERSHIP:</b> Educational Body</p>		<p>Contact: Steve Crow (LA) 020 8921 5034</p>

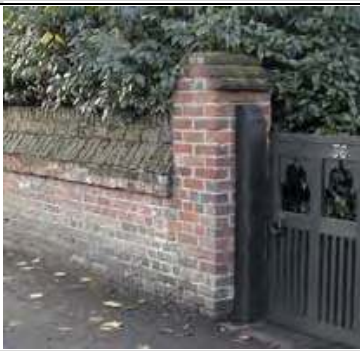
<p><b>SITE NAME:</b> Old brick wall between gardens in front of Nos. 34 and 36, Court Yard, Eltham SE9</p> <p><b>DESIGNATION:</b> Listed Building Grade II*, CA</p> <p><b>CONDITION:</b> Fair</p> <p><b>OCCUPANCY:</b> Not applicable</p> <p><b>PRIORITY:</b> C (C)</p>	<p>Brick wall with sloped coping of C16 appearance. In poor structural condition and suffering from vandalism.</p>

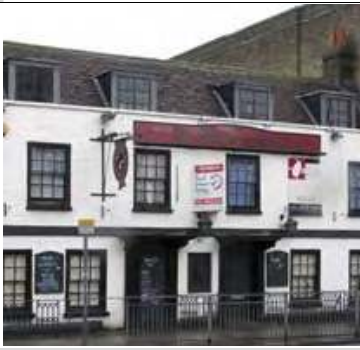
<p><b>SITE NAME:</b> The Greyhound public house, 86 Eltham High Street SE9</p> <p><b>DESIGNATION:</b> Listed Building Grade II</p> <p><b>CONDITION:</b> Poor</p> <p><b>OCCUPANCY:</b> Vacant</p> <p><b>PRIORITY:</b> D (C)</p>	<p>Unusual early C18 house with two entrance doorways. Vacant for a number of years and deteriorating. Scheme for repair and refurbishment approved in 2009 but not implemented.</p>
<p><b>OWNERSHIP:</b> Company</p>		<p>Contact: Steve Crow (LA) 020 8921 5034</p>

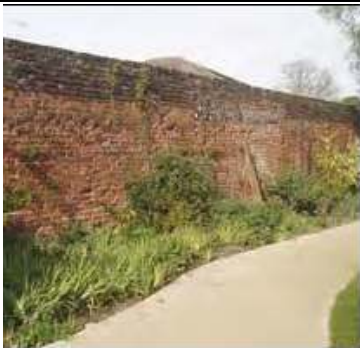
<p><b>SITE NAME:</b> Walls around garden to north of presbytery of Roman Catholic Church, Eltham High Street, Eltham SE9</p> <p><b>DESIGNATION:</b> Listed Building Grade II</p> <p><b>CONDITION:</b> Poor</p> <p><b>OCCUPANCY:</b> Not applicable</p> <p><b>PRIORITY:</b> A (A)</p> <p><b>OWNERSHIP:</b> Religious organization</p>	<p>Brick walls C16 or C17 with trace of sloped coping. Possibly part of gardens to Eltham House. Structurally unsound; some top courses missing and in danger of collapsing into yards behind.</p> <p>Contact: Steve Crow (LA) 020 8921 5034</p>

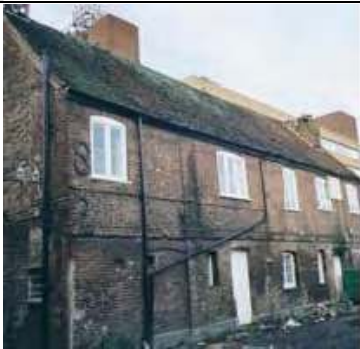
<p><b>SITE NAME:</b> 95A Eltham High Street, Eltham SE9</p> <p><b>DESIGNATION:</b> Listed Building Grade II</p> <p><b>CONDITION:</b> Fair</p> <p><b>OCCUPANCY:</b> Part occupied</p> <p><b>PRIORITY:</b> C (C)</p> <p><b>OWNERSHIP:</b> Private</p>	<p>C17 or earlier stable building with three diagonal chimney shafts. Although it has been made weathertight, it is vulnerable to vandalism and pigeons. Previously in use as a joinery workshop, most appropriate future uses would be commercial/office use.</p> <p>Contact: Steve Crow (LA) 020 8921 5034</p>

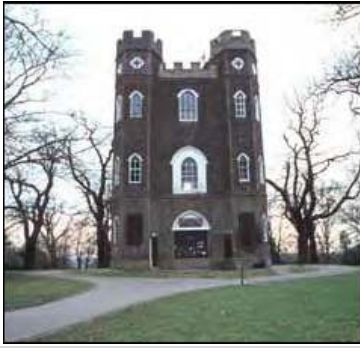
<p><b>SITE NAME:</b> Severndroog Caste, Shooters Hill SE18</p> <p><b>DESIGNATION:</b> Listed Building Grade II*</p> <p><b>CONDITION:</b> Fair</p> <p><b>OCCUPANCY:</b> Vacant</p> <p><b>PRIORITY:</b> D (D)</p> <p><b>OWNERSHIP:</b> Local authority</p>	<p>Gothick tower built in 1784 to commemorate the conquest of the Malabar Coast by Sir William James in 1755. Stands in woodlands and suffers from vandalism. Preservation Trust set up to secure restoration of the building. Heritage Lottery Funded scheme of repairs and alterations agreed, with English Heritage grant.</p> <p>Contact: Malcolm Woods 020 7973 3769</p>

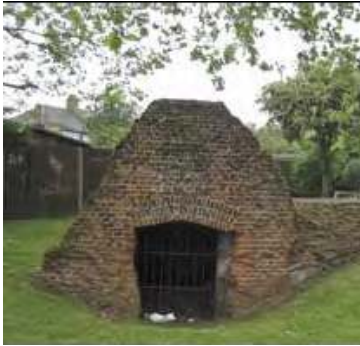
<p><b>SITE NAME:</b> Conduit Head, Southend Crescent, Eltham SE9</p> <p><b>DESIGNATION:</b> Scheduled Monument</p> <p><b>CONDITION:</b> Very bad</p> <p><b>OCCUPANCY:</b> Not applicable</p> <p><b>PRIORITY:</b> B (A)</p>	<p>Brick conduit house, probably C16, built to provide a water supply to Eltham Palace. Situated on a small triangle of public open space adjacent to Holy Trinity church. In danger of structural failure and subject to vandalism. A management agreement between the LA and EH is under discussion which will include provision for capital works and regular maintenance.</p>
<p><b>OWNERSHIP:</b> Local authority</p>		<p>Contact: Jane Sidell 020 7973 3738</p>

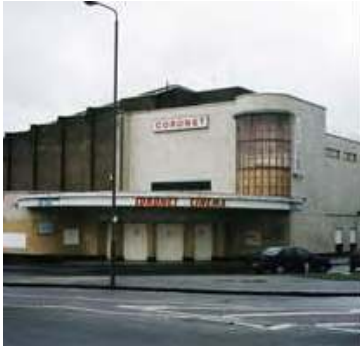
<p><b>SITE NAME:</b> Coronet Cinema, Well Hall Road, Eltham SE9</p> <p><b>DESIGNATION:</b> Listed Building Grade II</p> <p><b>CONDITION:</b> Poor</p> <p><b>OCCUPANCY:</b> Vacant</p> <p><b>PRIORITY:</b> D (D)</p>	<p>Former Odeon cinema built 1936 to the design of Andrew Mather and Horace Ward. Faience cladding to front. Good internal features in foyers, stairs and auditorium. Closed in 1999 and subject to vandalism. Now in new ownership. Planning permission and listed building consent granted for redevelopment in 2008.</p>
